# VIBRATION SENSORS: LISTENING FOR NETWORK LEAKS

*E. Mofardin (author and key presenter); D. Bergmann; A. Forster-Knight; J. Londono; J. Crook; A. Bailey  
South East Water  
101 Wells St, Frankston, 3199, Victoria, Australia*

## ABSTRACT

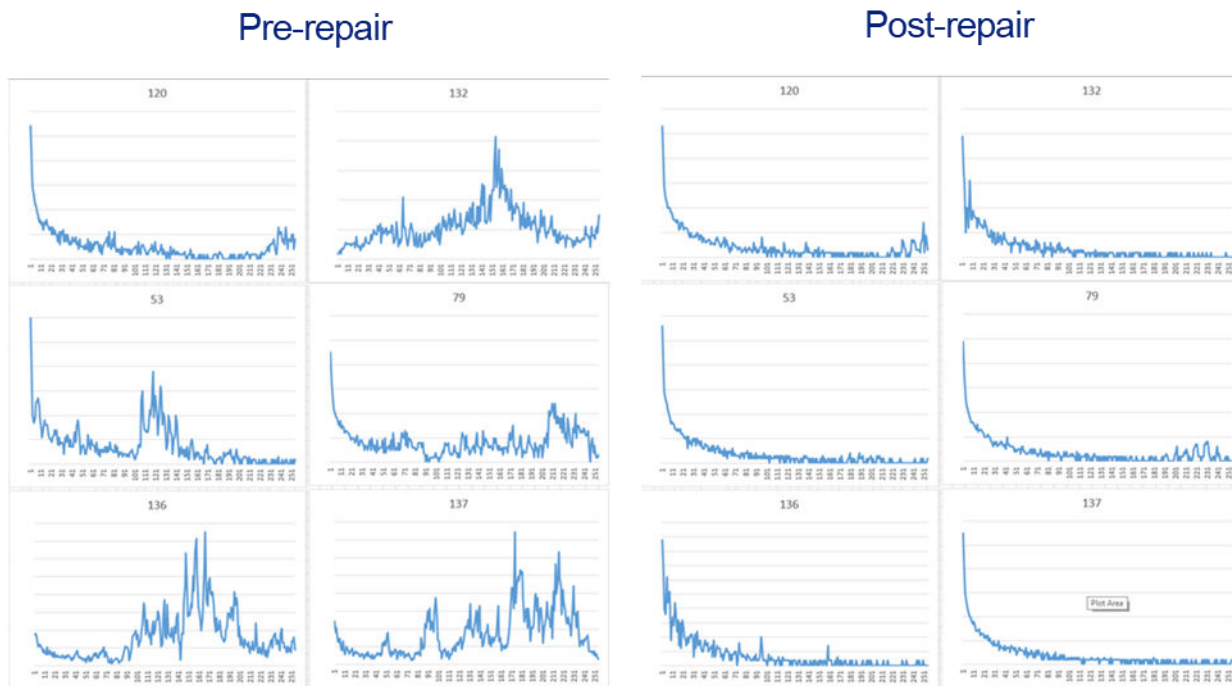
Figure 1: Examples of multiple Sotto® vibration signals pre (left) and post (right) repair of network leak

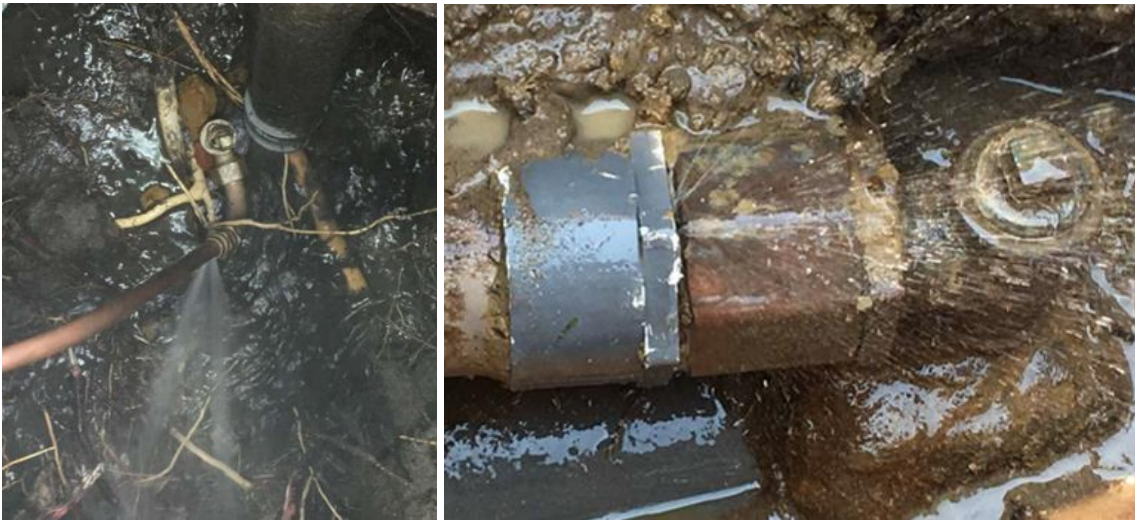
*Figure 2 (left): Service line leak at the connection to the main. Figure 3 (right): Leak on PVC main*

Water leaks on SEW's infrastructure are either on the water main, the service line connection, the service line itself or the stop tap and meter assembly. Most leaks at SEW occur on service lines and their connections to the main. In trying to detect these leaks, SEW also deploys a small group of leak detection operators using Fuji leak detection 'listening sticks' to detect hidden leaks. These operators walk SEW's network of one million meters reporting leaks as they hear them through their sensor equipment to address these leaks prior to them becoming apparent to the public.

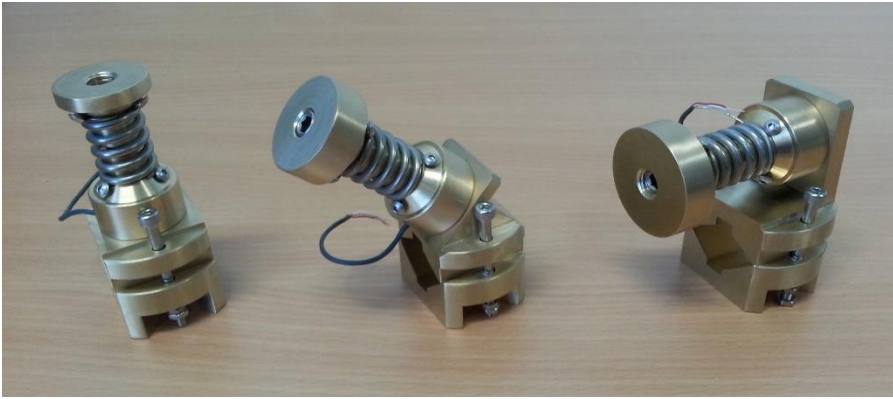
*Figure 4: Three examples of the sensor prototypes and mounting methods*

The initial work was conducted to document product requirements, understand the vibration sensor’s working environment and profile the leak signals to detect. Various prototypes were designed and manufactured with different seismic masses, spring rate suspension and vibration pick up to permit preliminary testing.

The prototypes are an attempt to understand whether the concept could work under ideal conditions. As such the designs incorporated only limited consideration of likely final product packaging, weight and cost constraints.

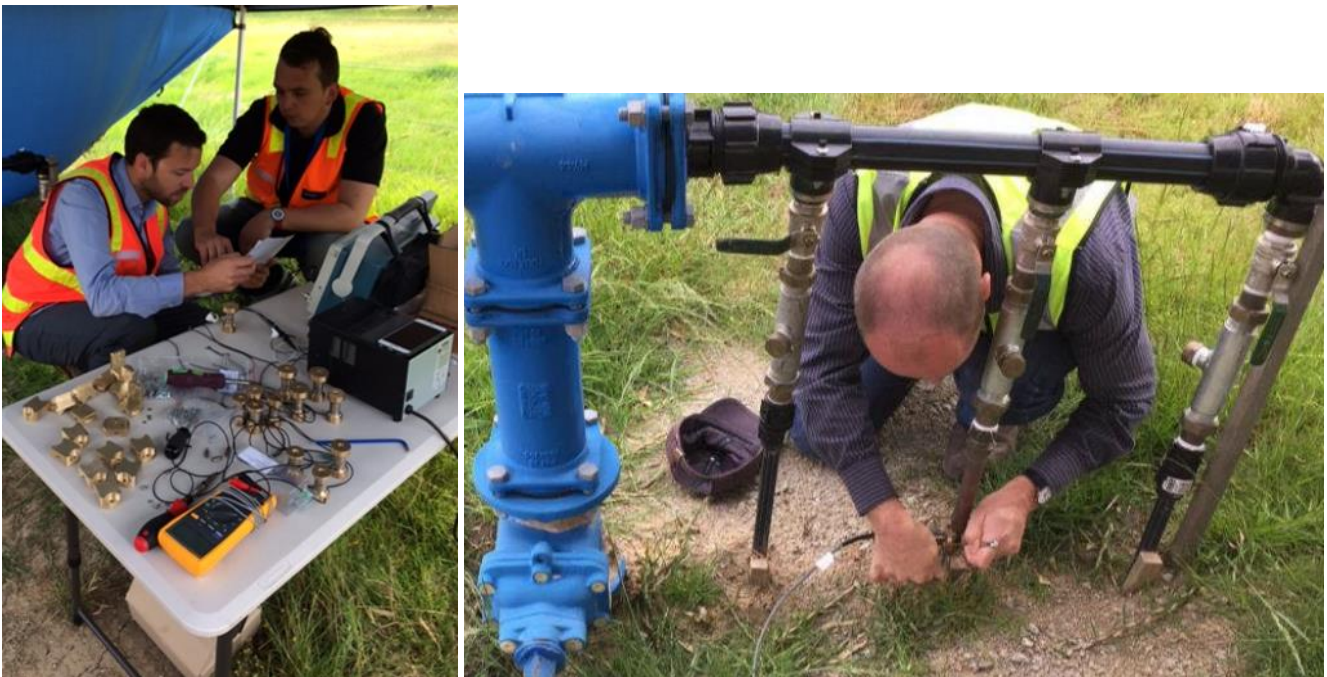
*Figure 5 (left): test rig instruments and prototypes. Figure 6 (right): installing mount pipe for prototypes*

A test rig was designed and built at SEW's Mt Martha Water Recycling Plant that would replicate the real-world environment of buried water mains with different materials. This would allow SEW to conduct testing in a controlled manner. Different leaks could be generated on the various pipe materials and the resultant leak vibrations detected with the prototype sensors and their respective performance compared. A reference sensor was installed to act as a datum to compare the performance of the prototypes.

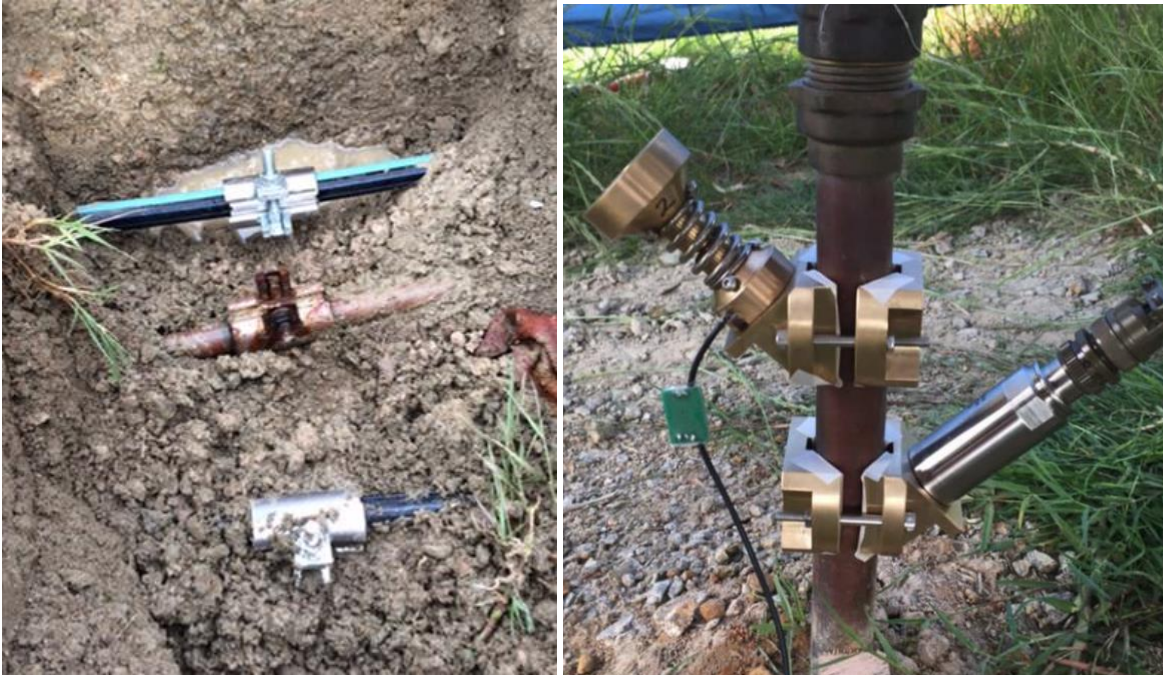
Figure 7 (left): exposed pipes where leaks were created by drilling. Figure 8 (right): prototype sensor and Meggitt Mems sensor used as a reference mounted to the test pipe

- Identified optimal vibration sensor pick-up technology
- An increase in seismic mass increased amplitude response
- Changes in seismic mass shifted the frequency response
- Able to detect most leaks with only the smallest being challenging
- Reference Mems sensor detected even the smallest leaks but with a very low amplitude response
- Increased leak size increased both response amplitude and bandwidth
- Increasing the seismic mass decreased the frequency of max amplitude
- Poly pipe amplitudes were smaller than copper pipe which also suggests vibrations travel through pipe material and not the water
- Increasing the size of the leak did not change significantly the frequency of maximum amplitude
- The closer the sensor was to the leak the higher the frequency components appeared

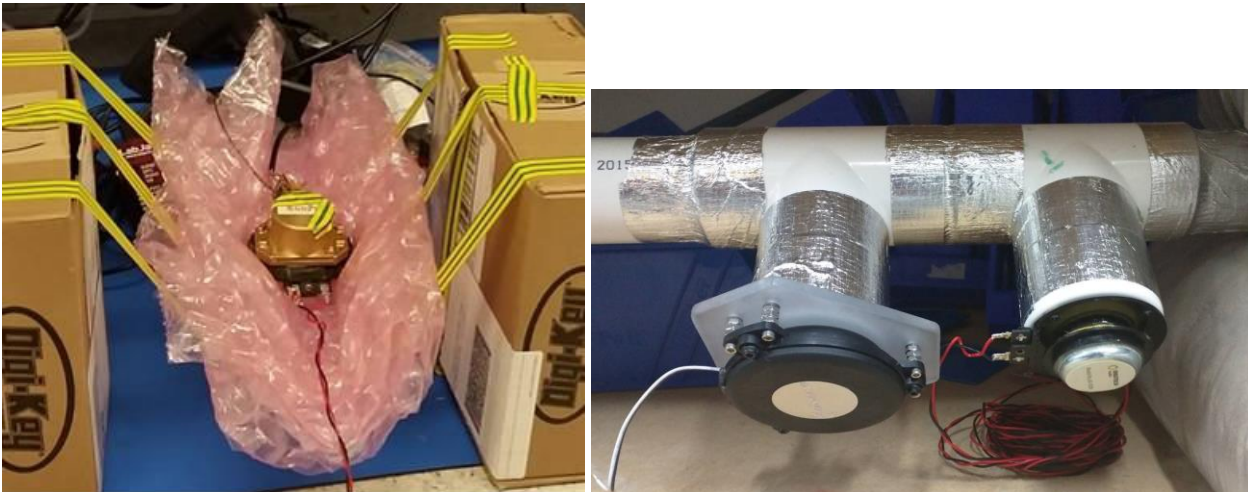
Figure 12 (left): background noise floor testing. Figure 13 (right): lab vibration test rig excitation diaphragms

Tests indicated the Alpha prototype had extraordinary sensitivity with distant vibrations in the building necessitating extreme efforts to isolate the test rig from these background noise sources.

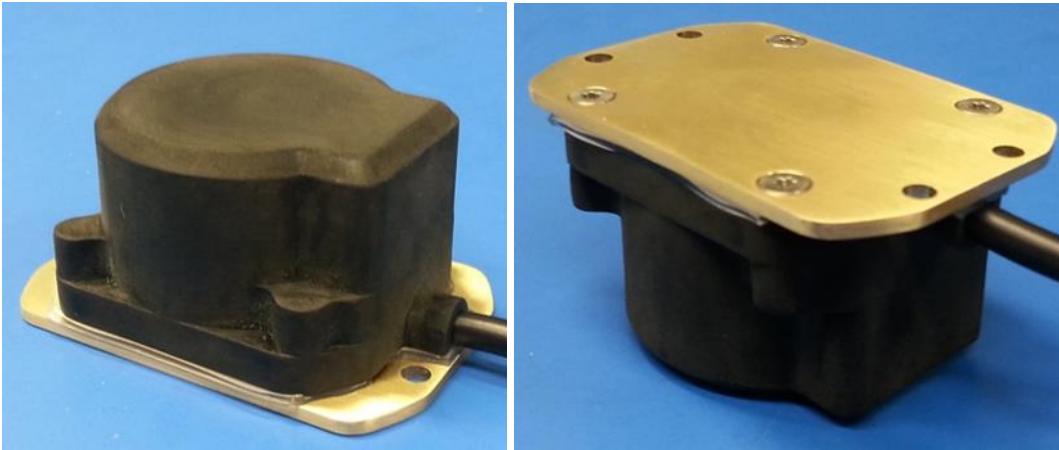
Figure 17 & 18: Beta design mock-up.

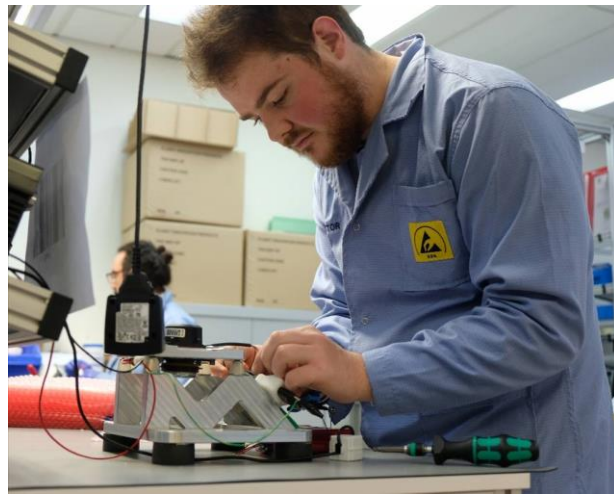
Figure 19 (left): manufacturing end-of-line tester design. Figure 20 (right): end-of-line tester in operation.

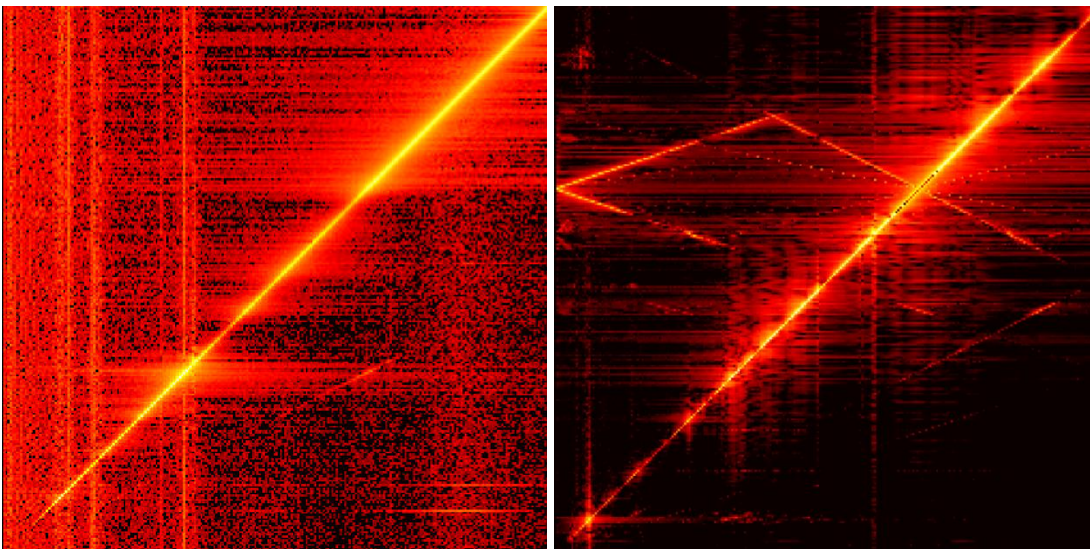
Figure 21 & 22: vibration response harmonics testing samples.

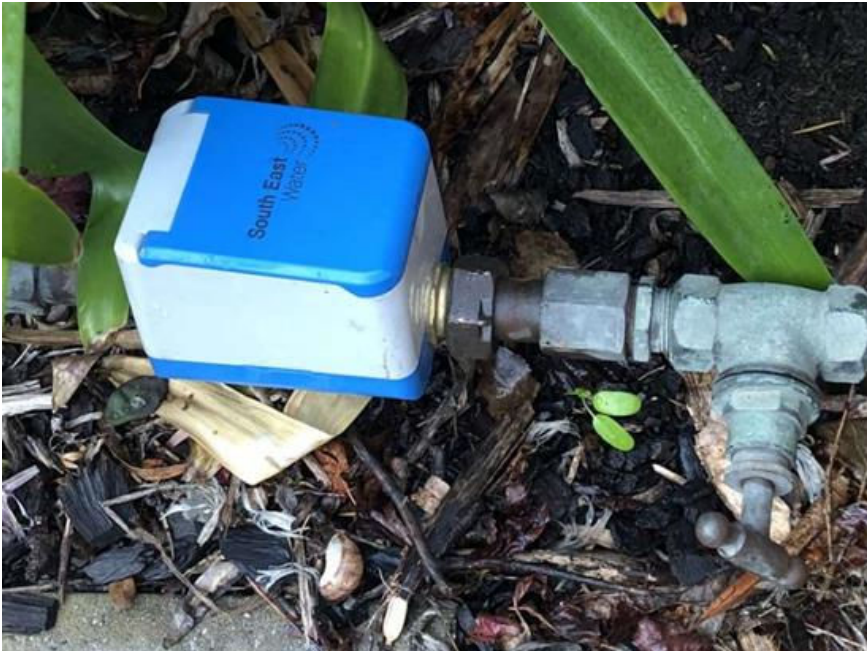
*Figure 24: Digital water meter containing the vibration sensor deployed on a residential property.*

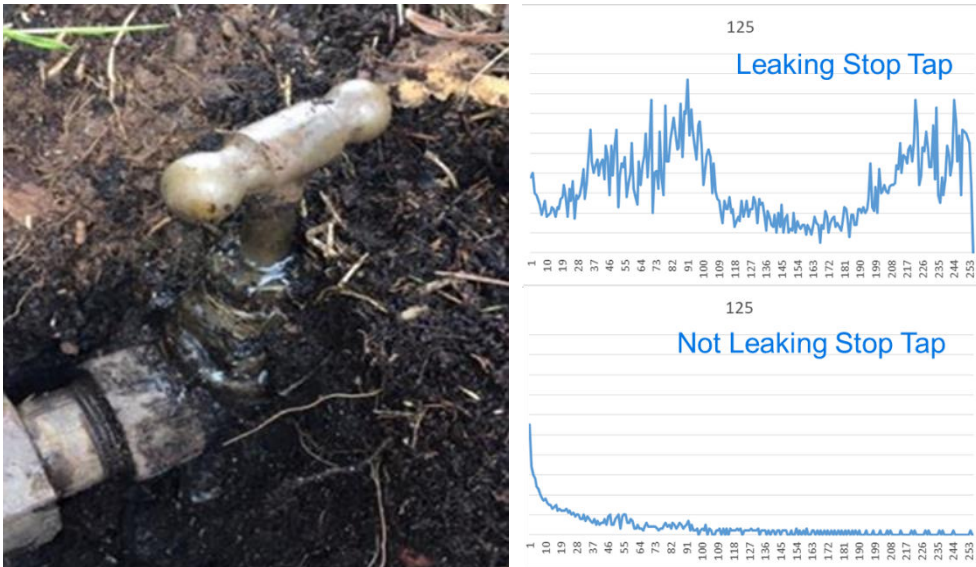
Figure 34 (left): seeping stop-tap. Figure 35 (right): stop-tap vibration plots

This trial also revealed how the sensor could detect the smallest of seeping stop-tap leaks. Sensor #125 showed a strong vibration signal and after some searching it was discovered to be correlated to a seeping stop tap.

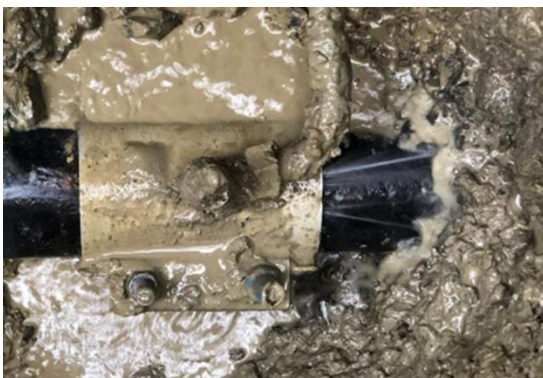
Figure 37: five days after leak was repaired the main was dug up revealing the failed repair.

This trial revealed sensor performance features that hadn't been expected. A leak on a water main was repaired by contractors but the sensor appeared to indicate otherwise. Over a period of 5 days the sensor revealed vibrations that could be seen growing steadily in size. The contractors were asked to go back out to site and discovered the clamp bolts were not tightened enough.

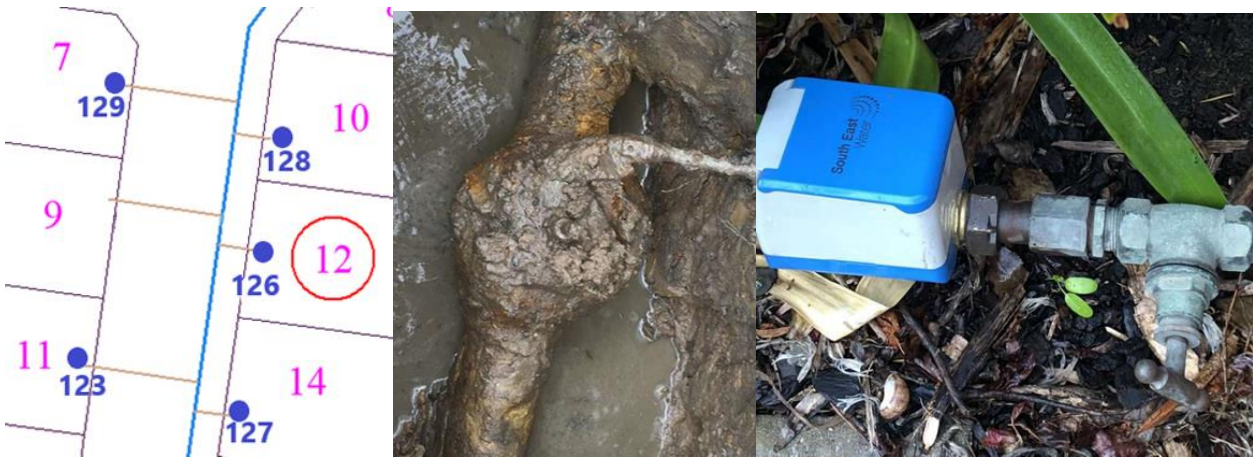
Figure 39 (left): water main and sensor GIS diagram. Figure 40 (middle): leaking service line connection. Figure 41 (right): leaking tail connection

A leak had come to the surface on this street and 5 sensors were deployed around the leak location. All sensors detected the leak. However, after the leak was repaired a strong signal continued to be detected on one of the sensors which turned out to be a leaking meter tail connection.
